## Pelican's Perch #83: The Shell Report

February 18, 2007

by John Deakin  
Columnist

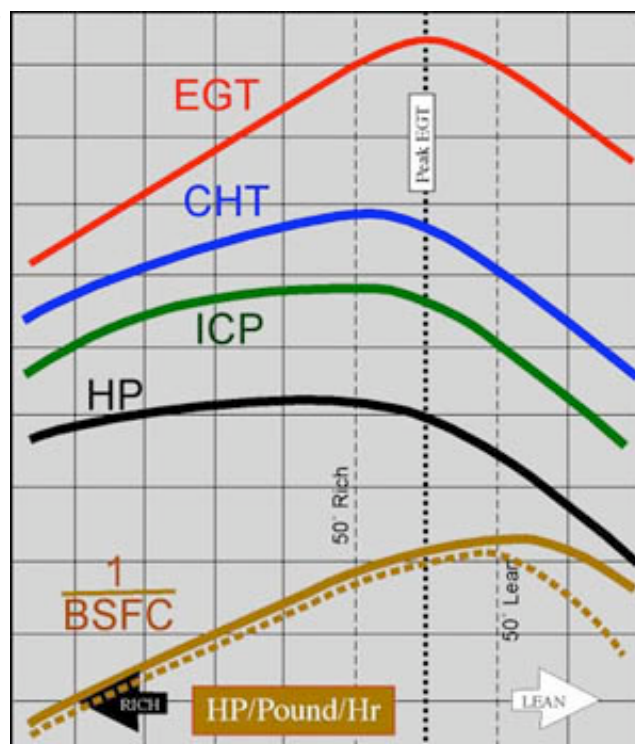
Here is a wonderful chart, found in the back of Teledyne Continental Motors (TCM) "Installation and Operation" manual for the IO-550 engine. Similar charts are found in most of the "big-bore" manuals, although the most recent of them now omit a lot of very good data, including this chart. To this, we have added color, and a fifth trace for "ICP" which is internal combustion pressure as measured from pressure transducers in the engines on the test stand.

Piston engine combustion measurements.

This chart was produced at 25" of manifold pressure, and 2500 RPM. At those settings, the mixture is leaned from rich (on the left) to lean (on the right).

As you can see from the chart above, 50°F ROP is the worst possible place to operate from the standpoints of temperature (CHT) and pressure (ICP). That mixture causes the highest CHTs, and the highest ICPs. We think you can do it safely at 60 percent or maybe 65 percent power, but not much more. If you will operate *richer* or *leaner* from that point, you are safe in making more power. At 250°F ROP, you're safe with 100 percent power. If you'll run 90°F LOP, you're safe at 85 percent power. For simplicity, we teach a "red box" centered on 50°F ROP. It's a little skinny red box at 65 percent, and a great big fat one at 85 percent.

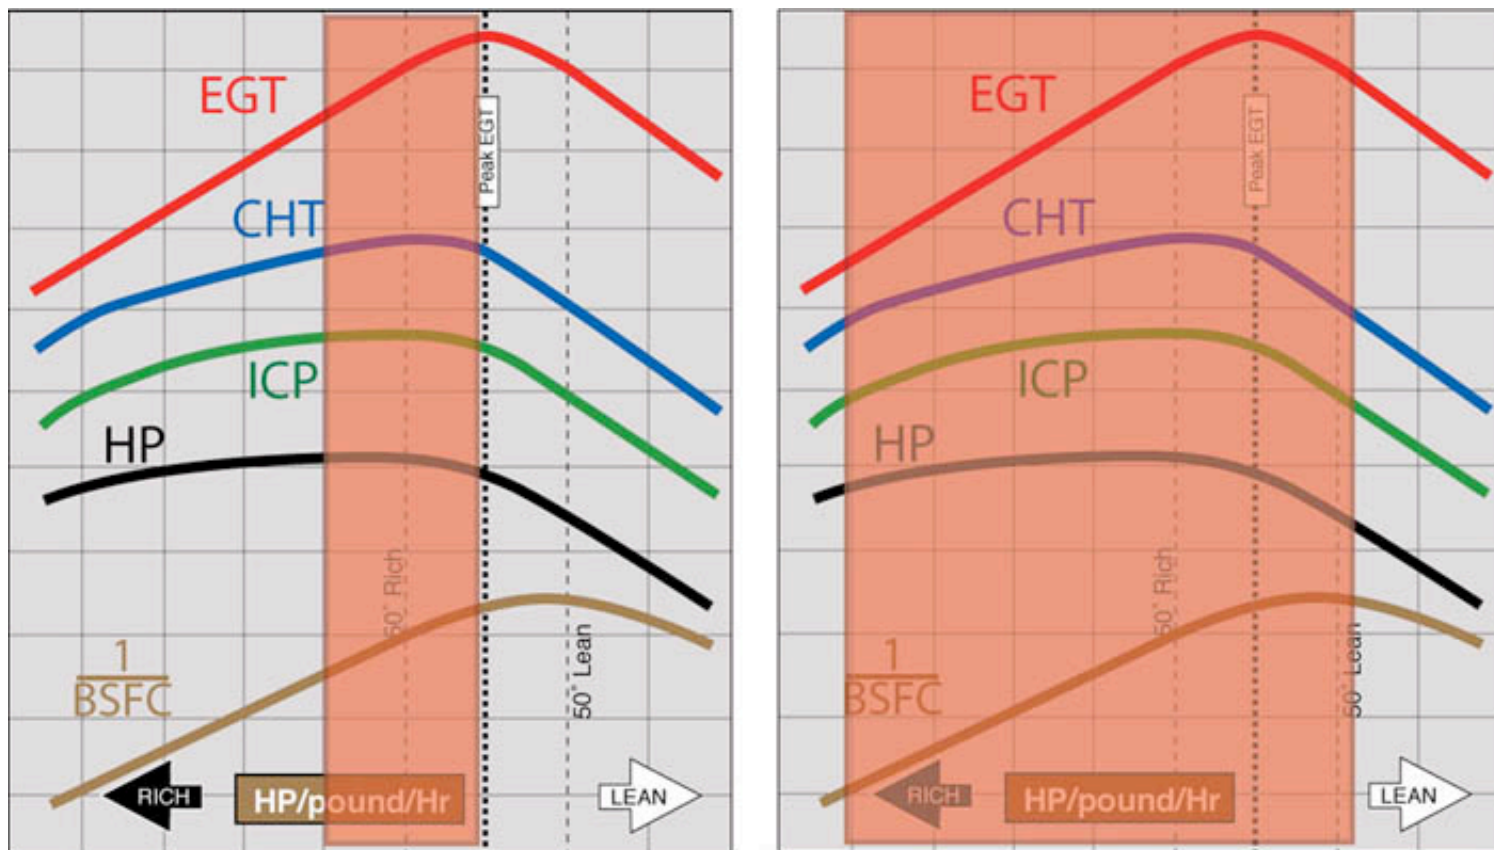
The "Red Box" danger zone for mixture settings at 65% power (left) and 80% power (right). For power settings between these two, the danger zone is correspondingly sized. At 60% power or less, there is no danger zone; you can set any mixture you like.
